Manhole Inspection Summary

Manhole # S29EE_011MH

Insp Date: **6/10/08 12:00 AM**

Location Address: **1214 JORDAN ST**

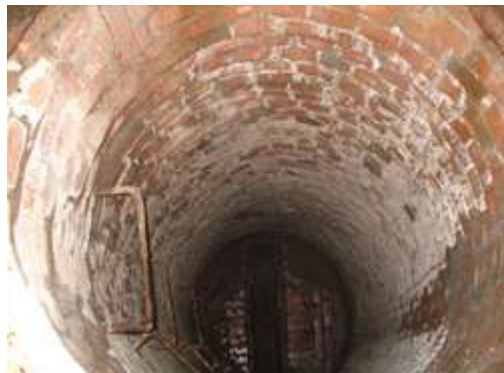
Top View

Corroded steps. Bench and Channel debris.

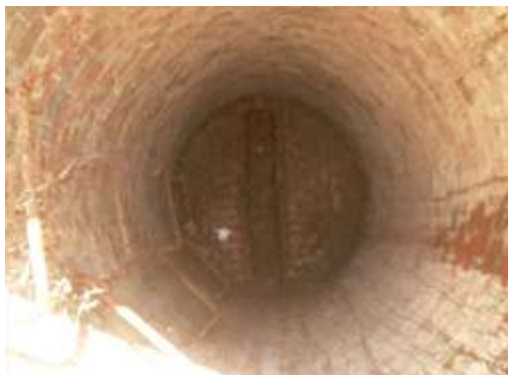
Top View

Corroded steps. Bench and Channel debris.

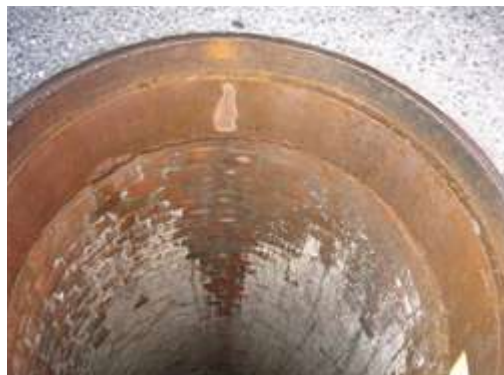
Defect

Frame Offset: **0** (in.) Condition: ☐ Sound ☐ Cracked ☒ **Leaks**

Infiltration: ☐ None ☒ **Joint** ☐ Cracks ☐ Mortar ☐ Roots ☐ Wall

Frame leaks. Adjustment infiltration.

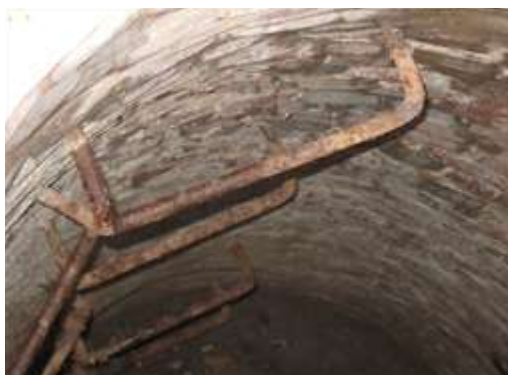
Defect

Infiltration: ☐ None ☐ Joint ☐ Cracks ☒ **Mortar** ☐ Roots ☒ **Wall**

Corbel and Barrel infiltration.

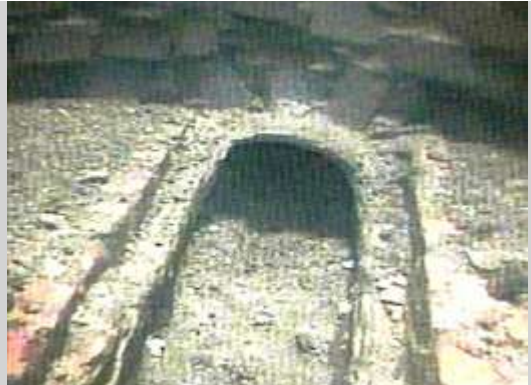
8 in. Circular Gravity Sewer Pipe Out @ 12 O'Clock

Barrel deterioration and infiltration.

Deposits: ☐ None ☒ **Mud** ☐ Sludge ☒ **Debris** ☐ Grease

Silt Depth: **1** (in.) Deposits Extent: **Light**

Infiltration: **Evidence** Pipe Seal Cond: **Unknown**

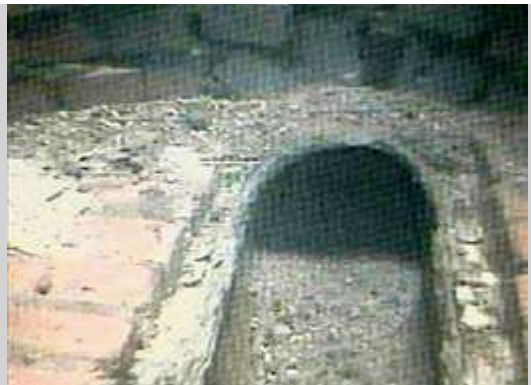
8 in. Circular Gravity Sewer Pipe In @ 6 O'Clock

Deposits: ☐ None ☒ **Mud** ☐ Sludge ☒ **Debris** ☐ Grease

Silt Depth: **1** (in.) Deposits Extent: **Light**

Infiltration: **Evidence** Pipe Seal Cond: **Unknown**
